REPORT #665863

1981 MERCEDES-BENZ SL 450

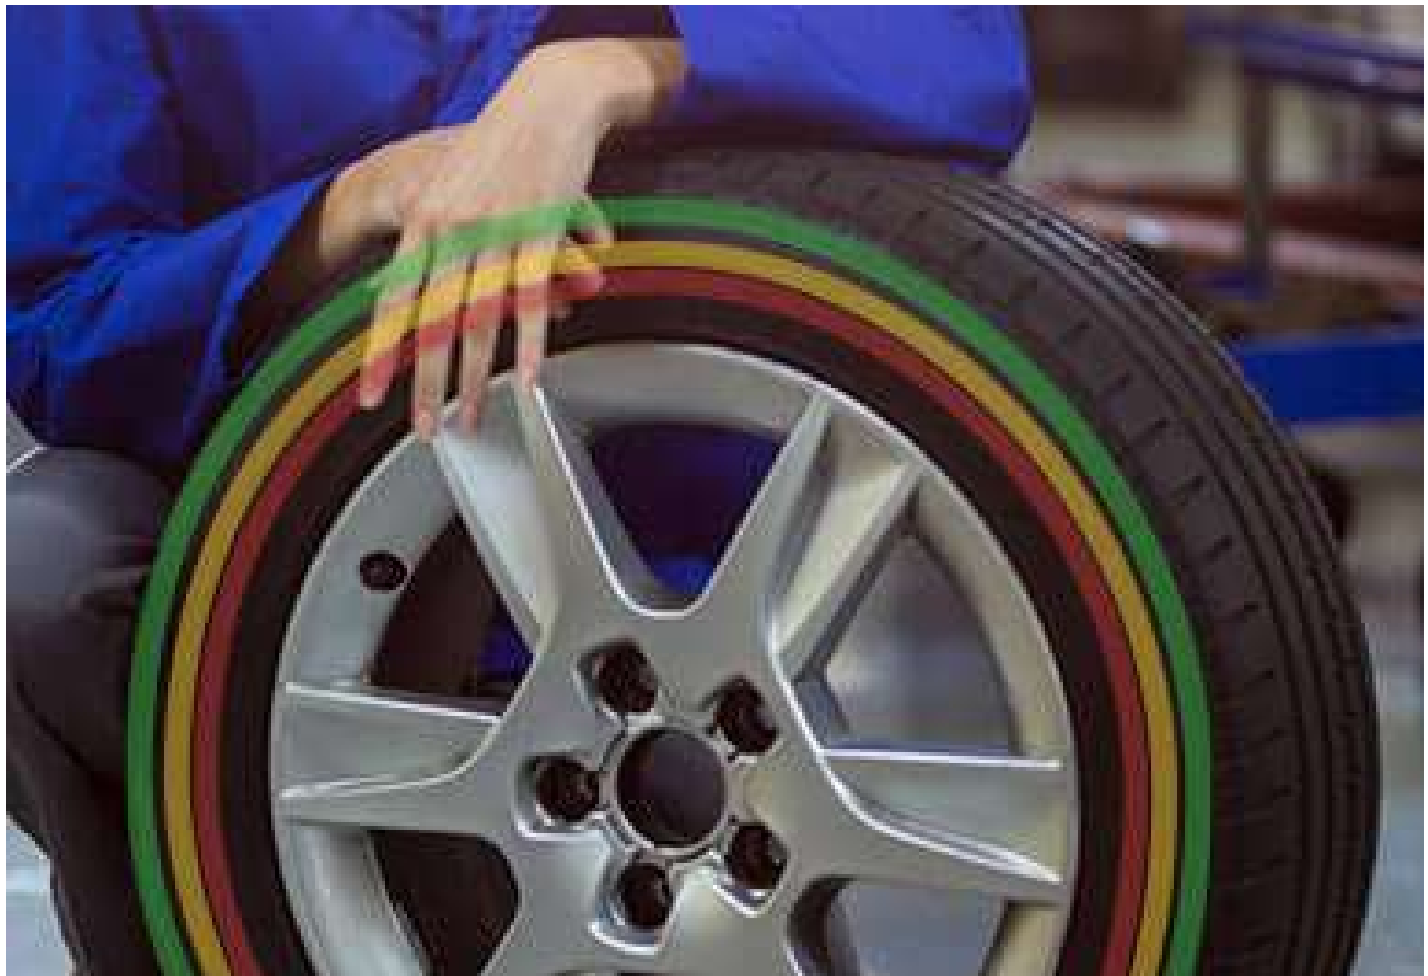
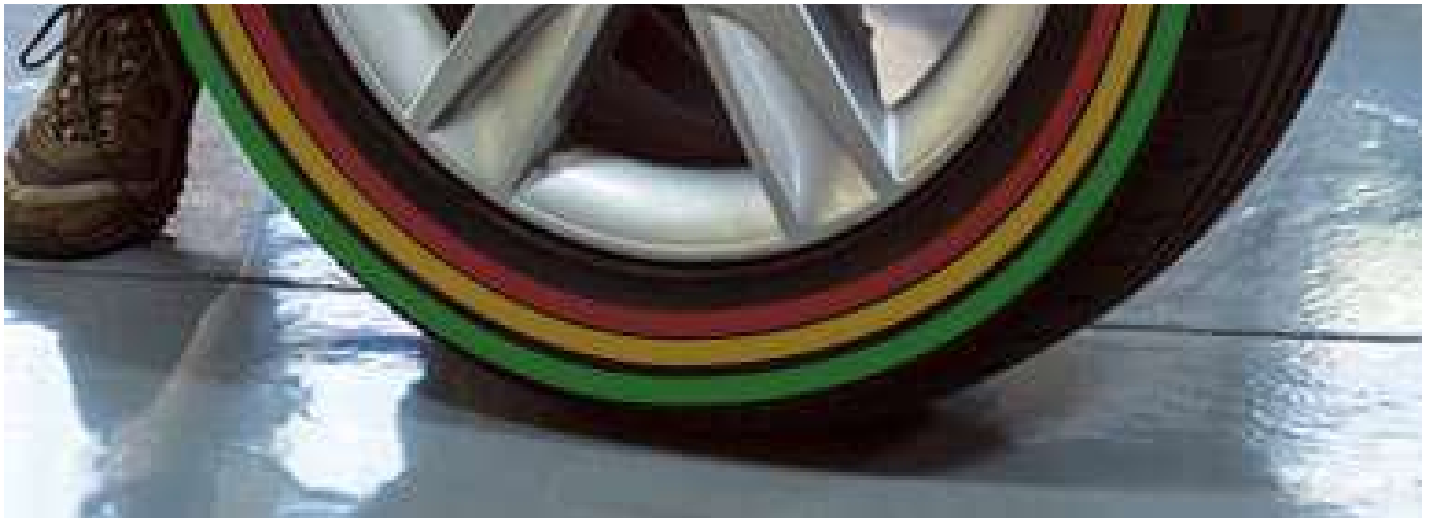
TIRE TREAD EXPLANATION

10/32 OR MORE

Tires have plenty of tread!
(standard)

8/32 OR MORE

Tires have plenty of tread!
(low profile)

5/32 TO 7/32

Tires will need replacement soon!

4/32 OR LESS

Tires need replacement!
